Material Testing Reports

RE: Lebanon National Cemetery Asbestos Survey
ASTI Project A6928

RE: Lebanon National Cemetery Lead Paint Survey
ASTI Project A6928

LEAD-BASED PAINT INSPECTION REPORT

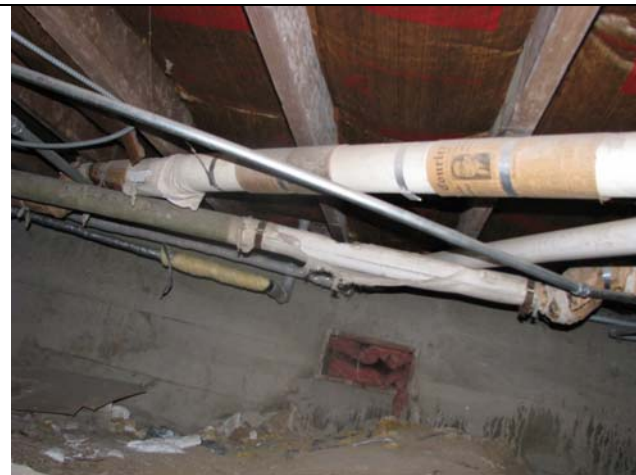
As you can see, lower roof coating, lower roof flashing, Kitchen linoleum, and 1st Floor Bathroom linoleum were identified as asbestos-containing materials. Crawlspace pipe insulation (under Kitchen) and exterior transite siding (2nd floor) were assumed to be asbestos-containing.

Photograph #1: Pipe insulation (assumed ACM) in crawlspace.

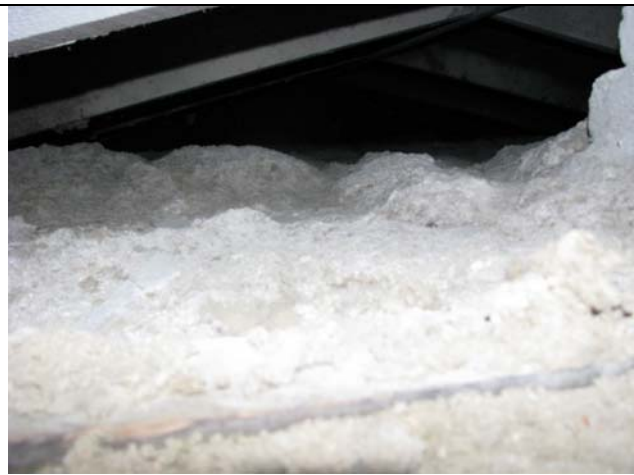
Photograph #2: Attic insulation (Sample A-1).

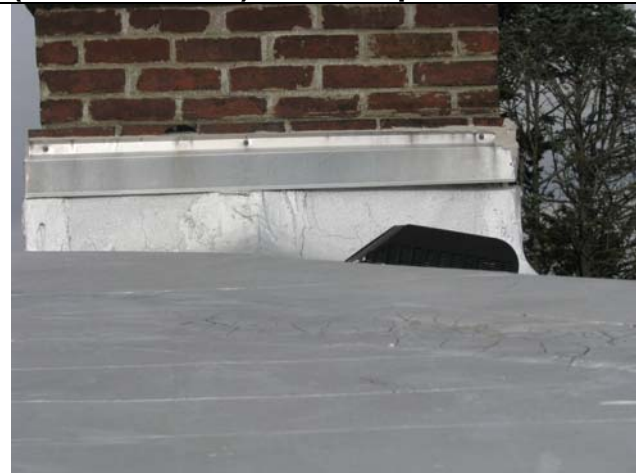
Photograph #3: Upper roof coating (Sample A-2).

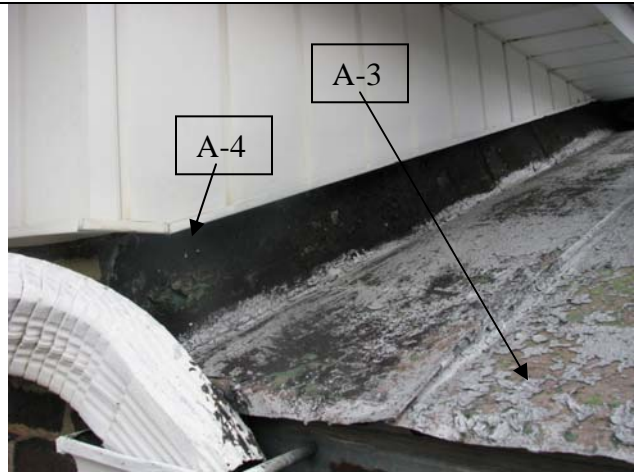
Photograph #4: Lower roof coating and flashing (Sample A-3 & A-4).

- A. Enclosed herein are the results of material tests performed on materials scheduled for removal.
- B. Removal of asbestos containing roof materials is work of this contract. Removal procedures shall conform to requirements contained in Specification Section 02 82 13.13 Glovebag Asbestos Abatement.
- C. Removal of lead containing paint products is work of this contract. Removal procedures shall conform to requirement contained in Specification Section 02 83 33.13 Lead Based Paint Removal and Disposal.

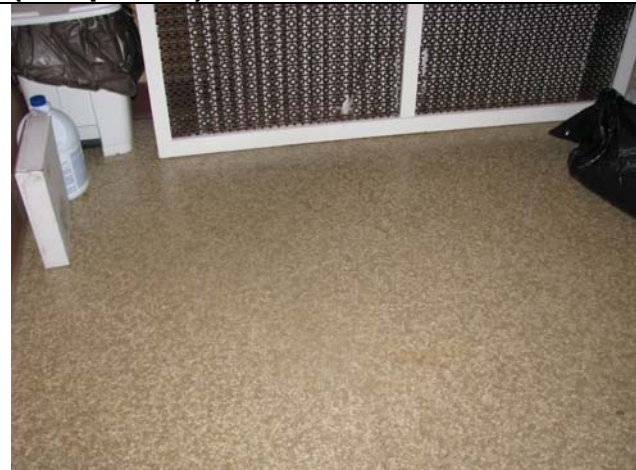
Photograph #5: Kitchen linoleum (Sample A-5).

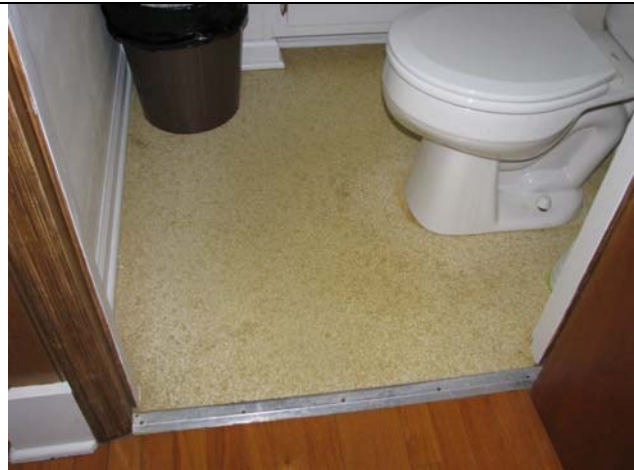
Photograph #6: 1st Floor Bathroom linoleum (Sample A-6).

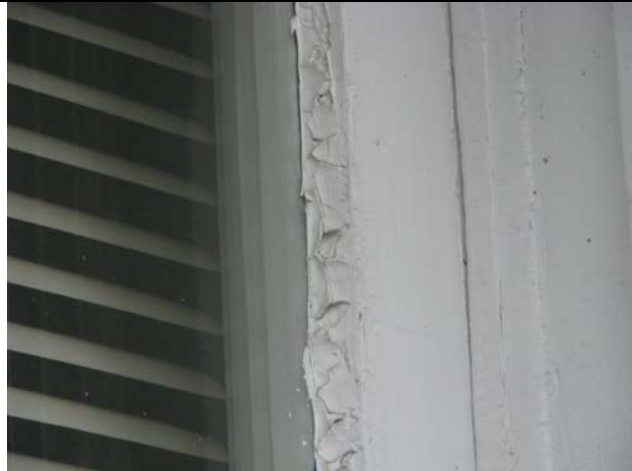
Photograph #7: Exterior window putty (Sample A-7).

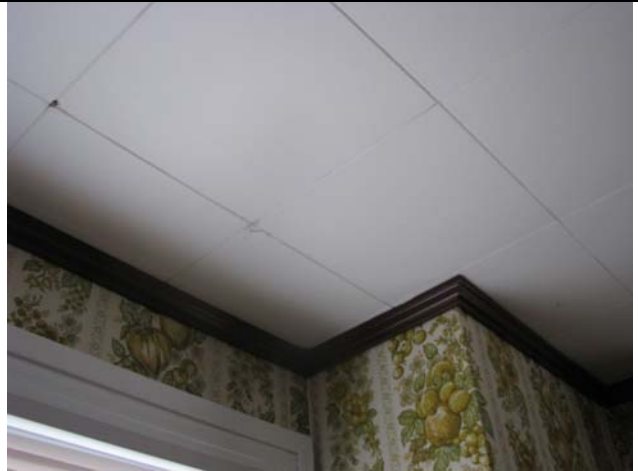
Photograph #8: Kitchen ceiling tile (Sample A-8).

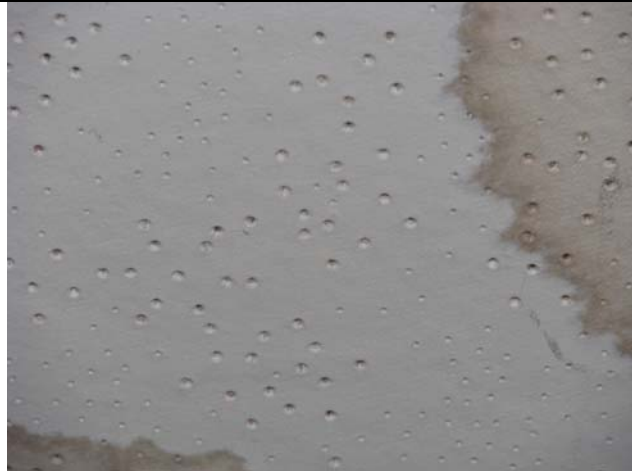
Photograph #9: 1st Floor Office 12'' ceiling tile with holes (Sample A-9).

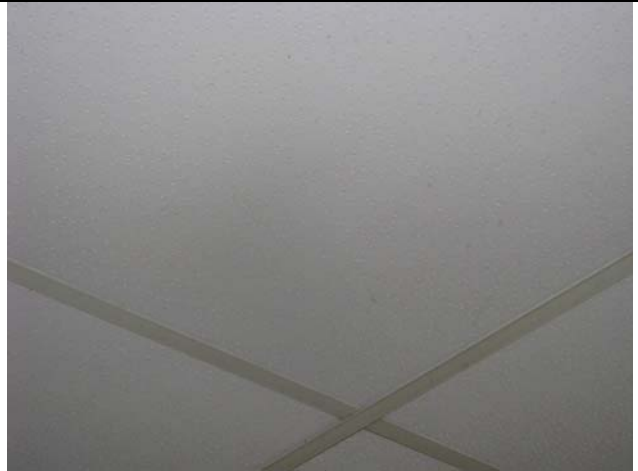
Photograph #10: 1st Floor Office drop ceiling tile (Sample A-10).

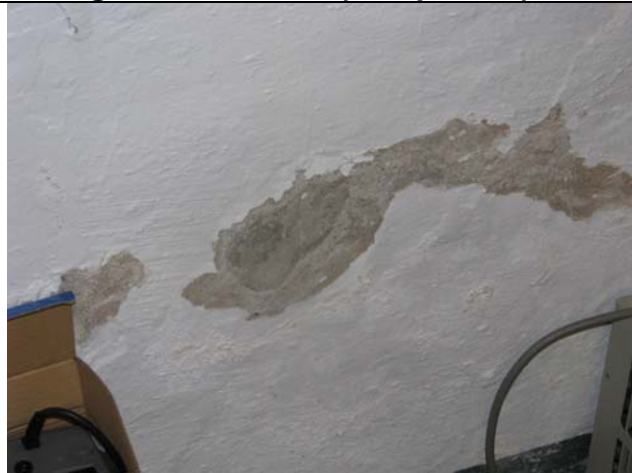
Photograph #11: Basement wall plaster (Sample A-11).

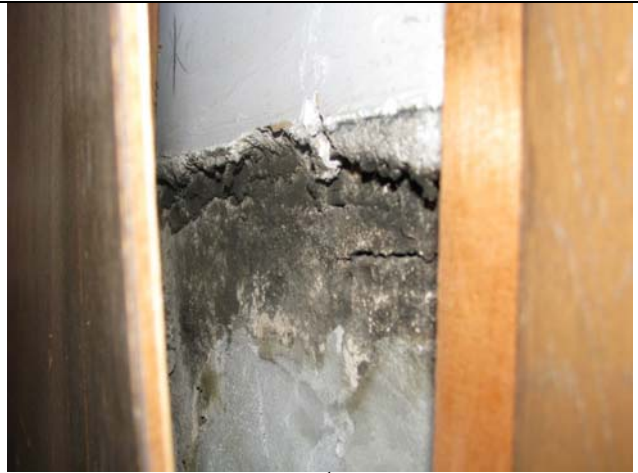
Photograph #12: 1st Floor Office wall plaster (Sample A-12).

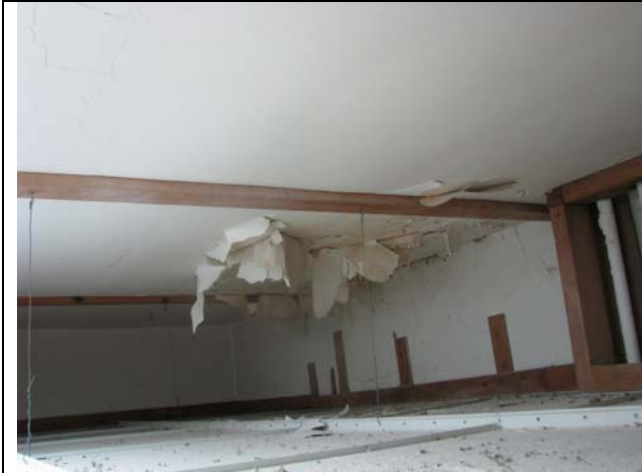
Photograph #13: 1st Floor Office ceiling plaster (Sample A-13).

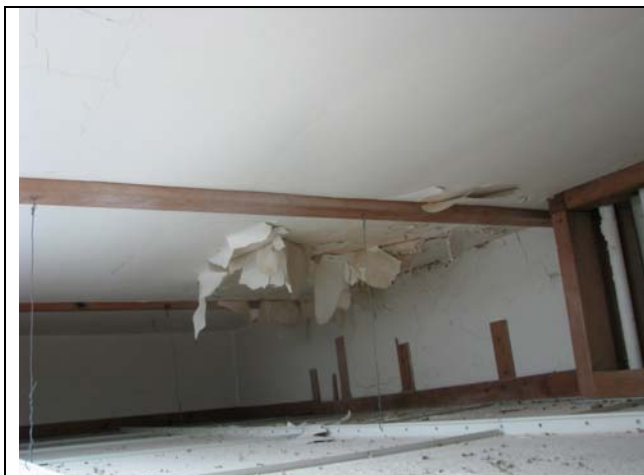
Photograph #1: 1st floor office ceiling paint (Sample L-1).

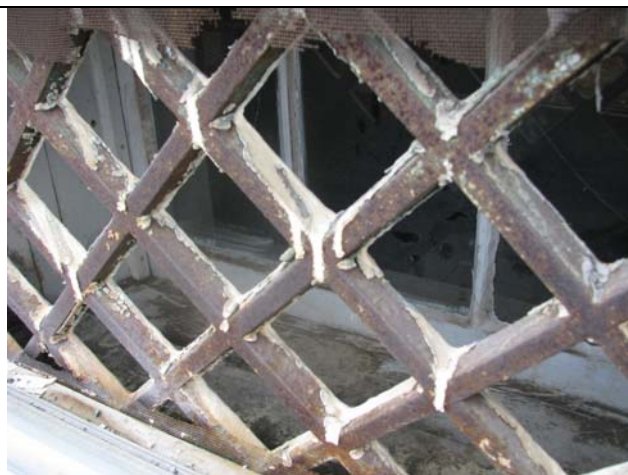
As you can see, lead paint was identified on the metal window grate, interior window sill, and interior basement ceiling.

Photograph #2: Metal window grate paint (Sample L-2).

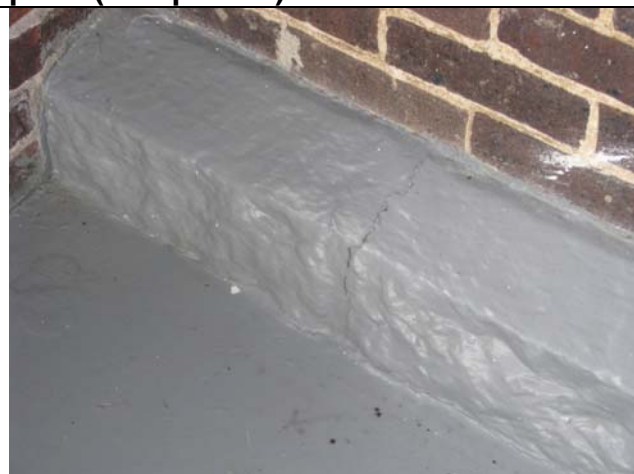
Photograph #3: Porch floor paint (Sample L-3).

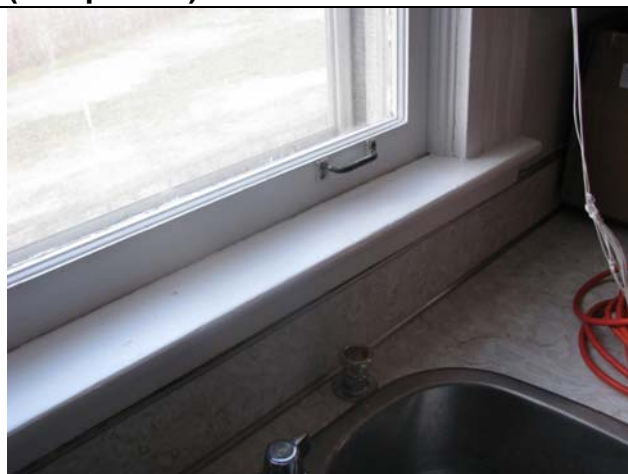
Photograph #4: Interior window sill paint (Sample L-4).

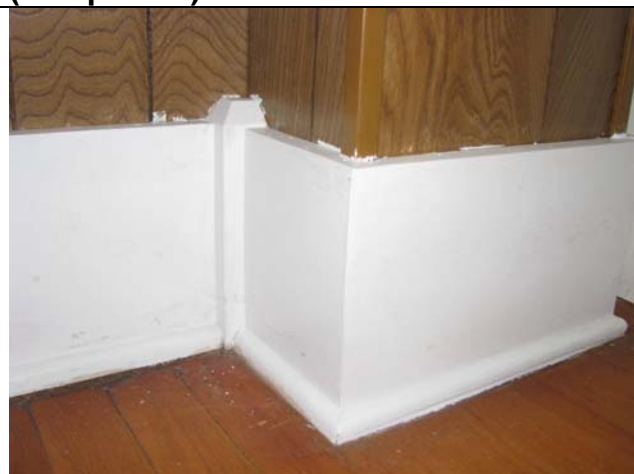
Photograph #5: 1st floor office baseboard paint (Sample L-5).

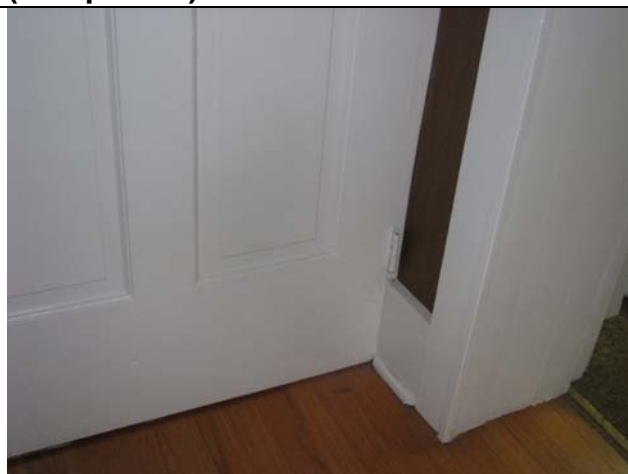
Photograph #6: 1st Interior door paint (Sample L-6).

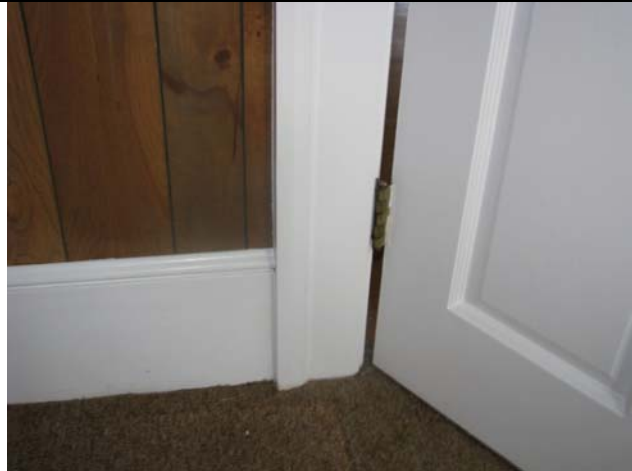
Photograph #7: Interior door trim paint (Sample L-7).

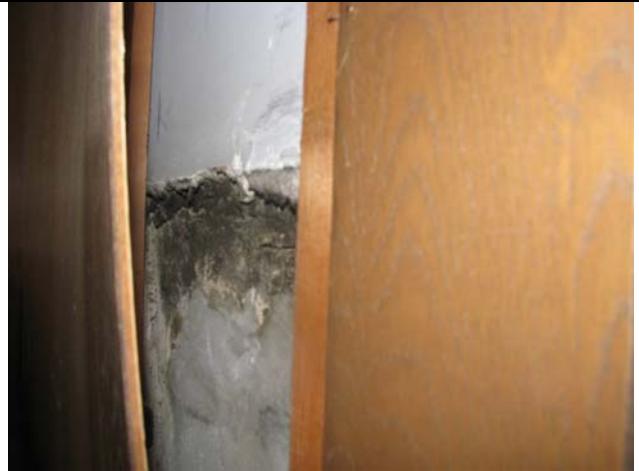
Photograph #8: Interior wall paint (Sample L-8).

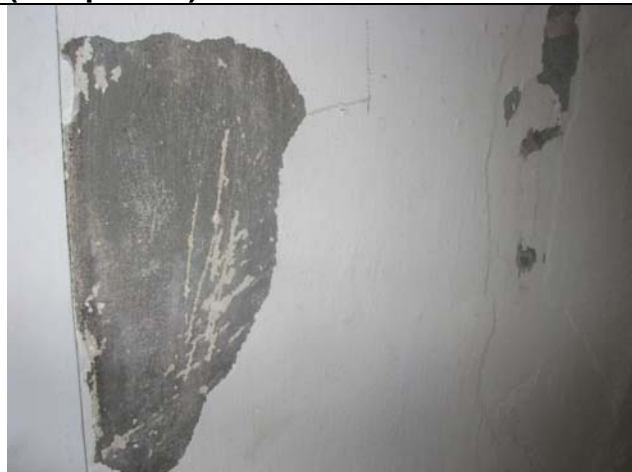
Photograph #9: Basement wall paint (Sample L-9).

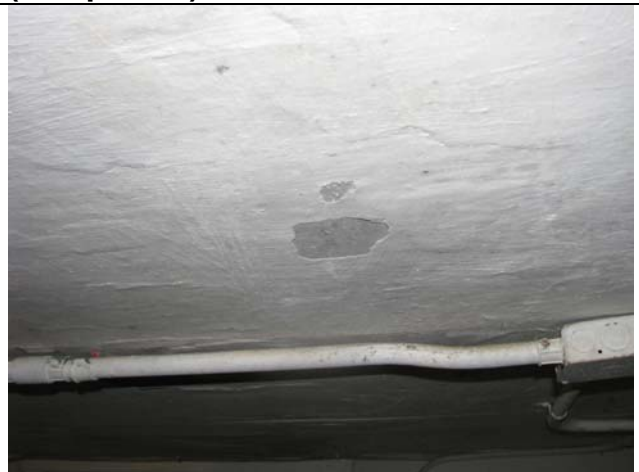
Photograph #10: Basement ceiling paint (Sample L-10).

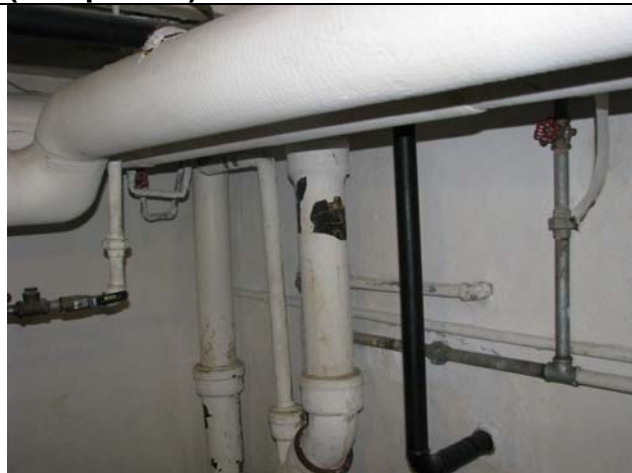
Photograph #11: Basement pipe paint (Sample L-11).

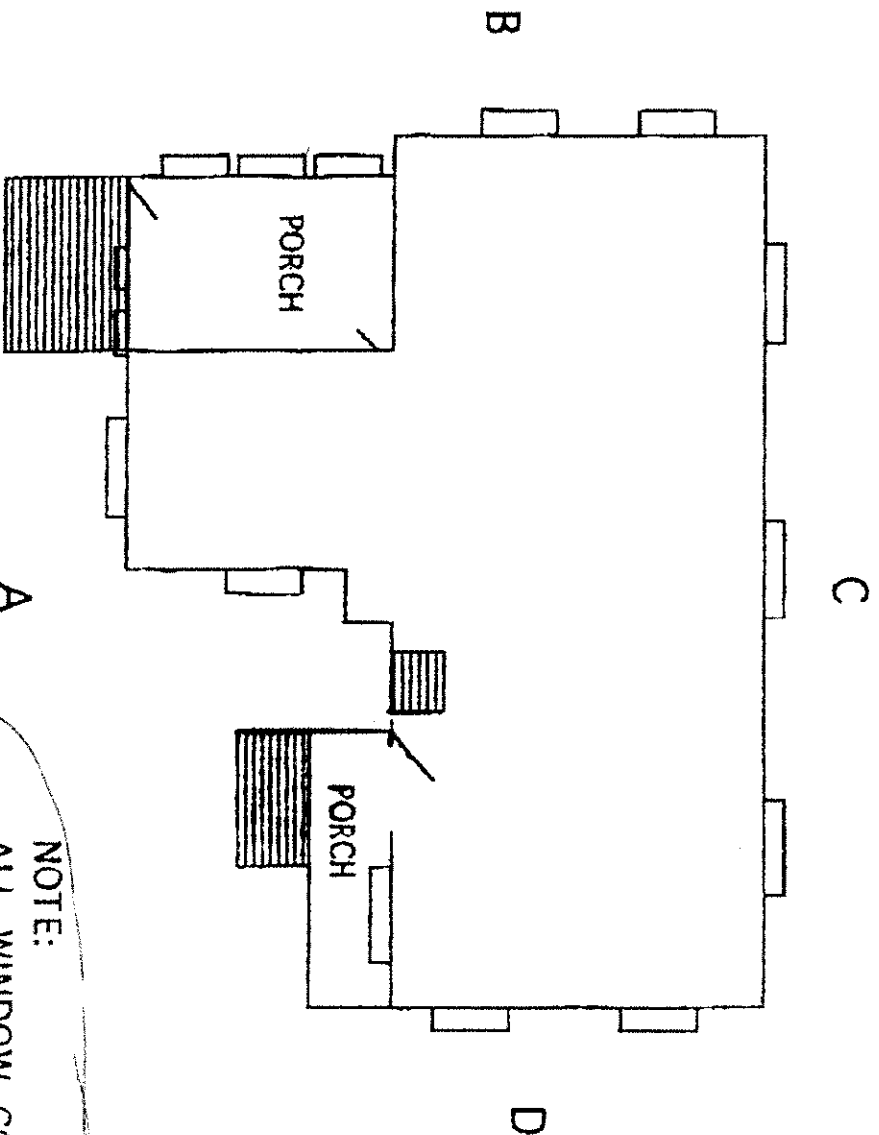
LODGE BUILDING

All Window components, Soffits, eaves, porch ceiling, walls, and metal roof tested positive for lead-based paint

The identified exterior lead-based paint on the Lodge was in fair condition. The identified exterior lead-based paint on the Maintenance building was in poor condition at the time

NOTE:
ALL WINDOW COMPONENTS,
SOFFETS, EVES, PORCH CEILING,
AND METAL ROOFING TESTED
POSITIVE FOR LEAD-BASED
PAINT
